#### MEMORANDUM

RE: Groundwater Sampling Activities at LL & S Landfill Site, Salem, Rockingham

County, New Hampshire, Technical Direction Document (TDD) Number (No.)

#### **INTRODUCTION**

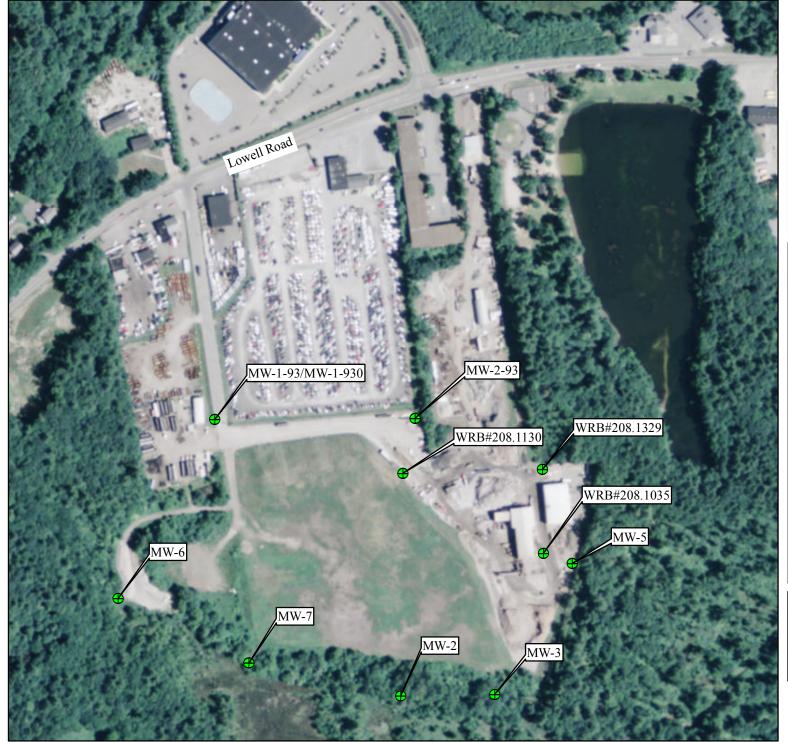
Figure 2

Site Diagram and Sample Location Map

Groundwater Sample Location

On 11 May 2016, START personnel George Mavris, Eric Ackerman, Bill Mahany, Andrew Danikas, and Chris Dupree; and EPA Site Assessment Manager (SAM) Martha Bosworth mobilized to Salem, Rockingham County, New Hampshire to collect groundwater samples from seven shallow on-site overburden monitoring wells and three deep bedrock production wells at the LL & S Landfill (see Attachment A, Figure 2).

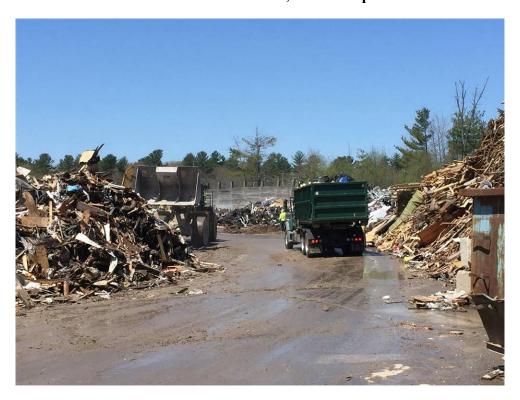
SCENE: View of construction and demolition debris at the LL & S Landfill site. Photograph taken facing northeast.

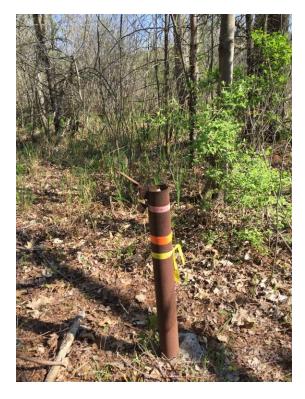
SCENE: View of monitoring well MW-3 located along the southern perimeter of the LL & S Landfill. Photograph

taken facing north.

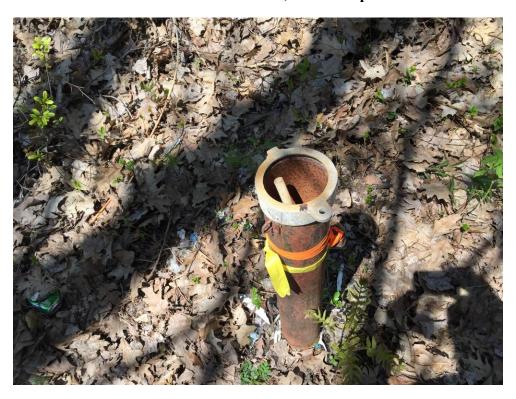
SCENE: View of monitoring well MW-3 and dedicated sampling tubing in well, located along the southern

perimeter of the LL & S Landfill.

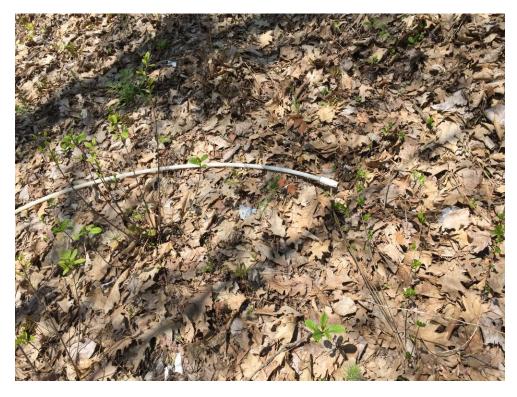
SCENE: View of dedicated sampling tubing removed from monitoring well MW-3 prior to purging and sampling.

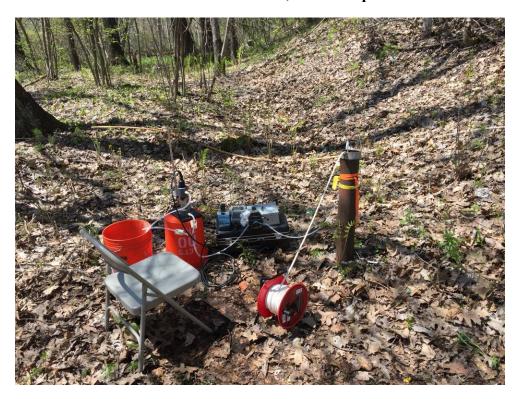
**SCENE:** View of low-flow groundwater sampling set-up at monitoring well MW-3 located along the southern perimeter of the LL & S Landfill. Photograph taken facing east.

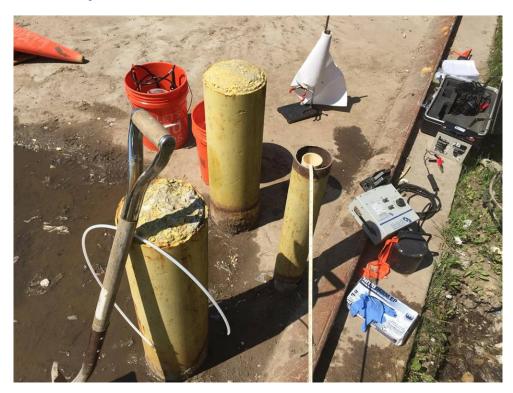
SCENE: View of monitoring well MW-5 located along the eastern perimeter of the LL & S Landfill.

Photograph taken facing northeast.

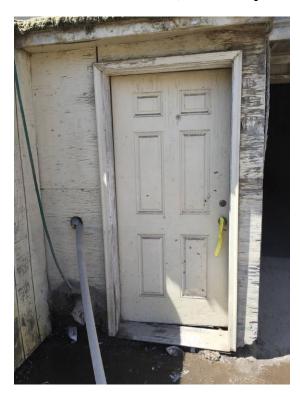
**SCENE:** View of door leading into building where bedrock supply well WRB#208.1035 is located.

Photograph taken facing south.

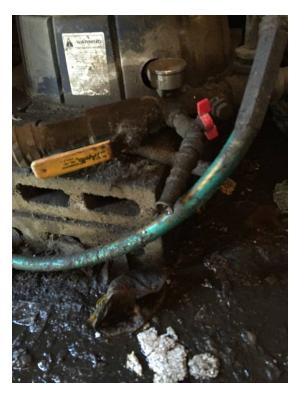
**SCENE:** View of sampling port for bedrock supply well WRB#208.1035.

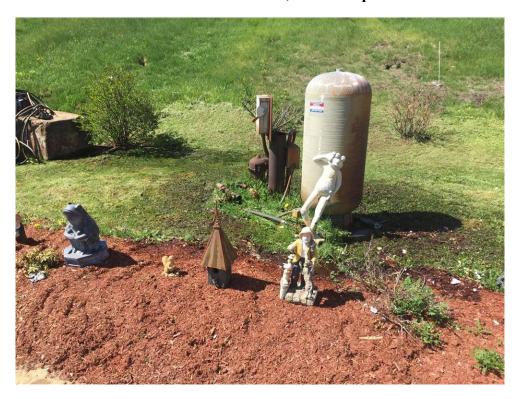
SCENE: View of bedrock supply well WRB#208.1130 and pressure tank located along the northeastern perimeter

of the LL & S Landfill. Photograph take facing southwest.

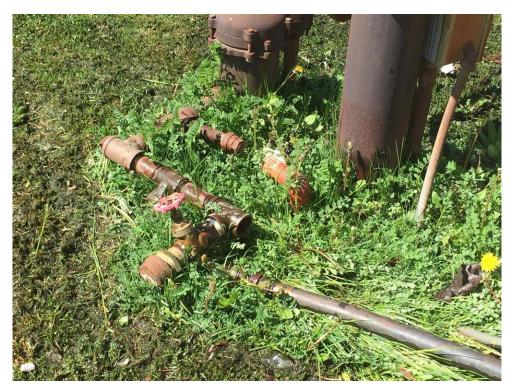
SCENE: View of sampling port for bedrock supply well WRB#208.1130 located along the northeastern perimeter of the

LL & S Landfill. Photograph take facing southwest.

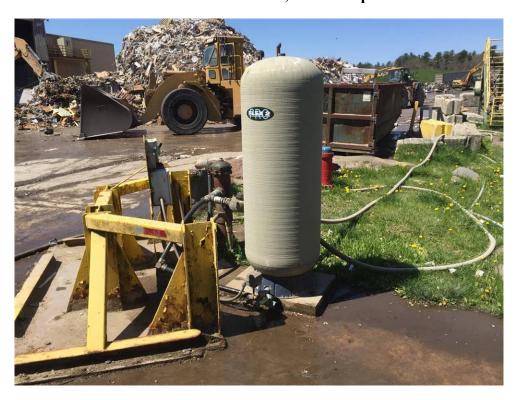
SCENE: View of bedrock supply well WRB#208.1329 and pressure tank located along the northeastern perimeter

of the LL & S Landfill. Photograph take facing southwest.

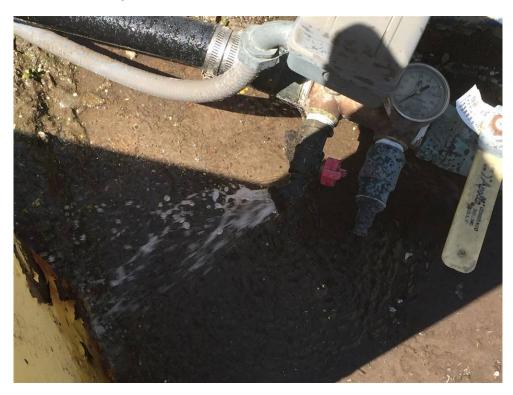
SCENE: View of sampling port for bedrock supply well WRB#208.1329 located along the northeastern perimeter of the

LL & S Landfill. Photograph take facing southwest.
